LaGrange Medical Mall  
PVC Roof Restoration

60 mil TritoFlex 2K membrane  
20 mil TritoCryl 1K top coat

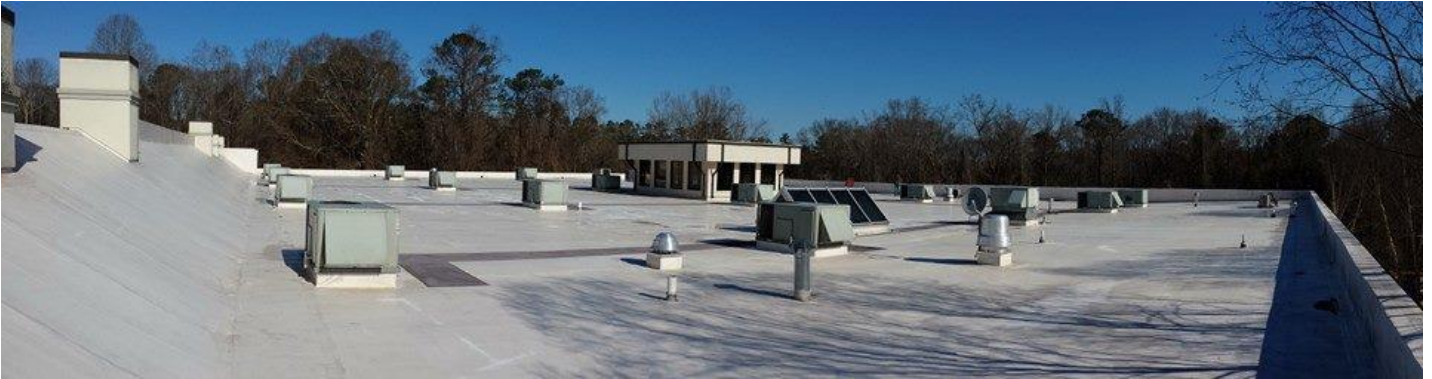
This 10-year old PVC white single-ply roof system had been severely damaged by hail, resulting in numerous membrane fractures and leak points.

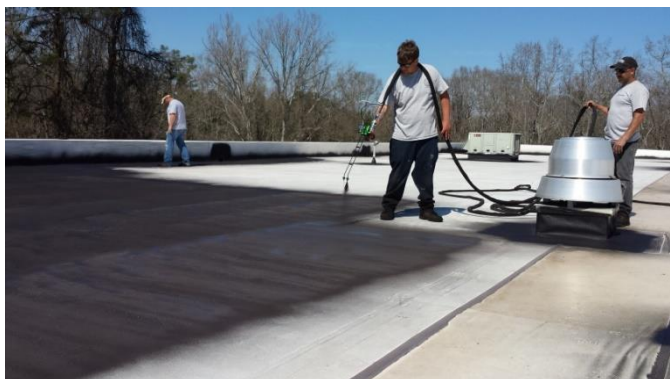
After pressure washing and removing all of the walk pads to ensure no moisture was trapped in the existing system, the TritoFlex 2K two-component rubberized membrane was installed in one coat with a spray application directly over the existing PVC single-ply roof system to achieve a 60 mil/1.5mm seamless membrane. This added to the existing 60 mil PVC, resulting in a total of 120 mils of waterproofing. It was then top coated with two coats of TritoCryl acrylic roof coating at 20 mils/0.5mm to provide superior energy cost savings in the hot summers and protect the membrane as a sacrificial layer for decades.

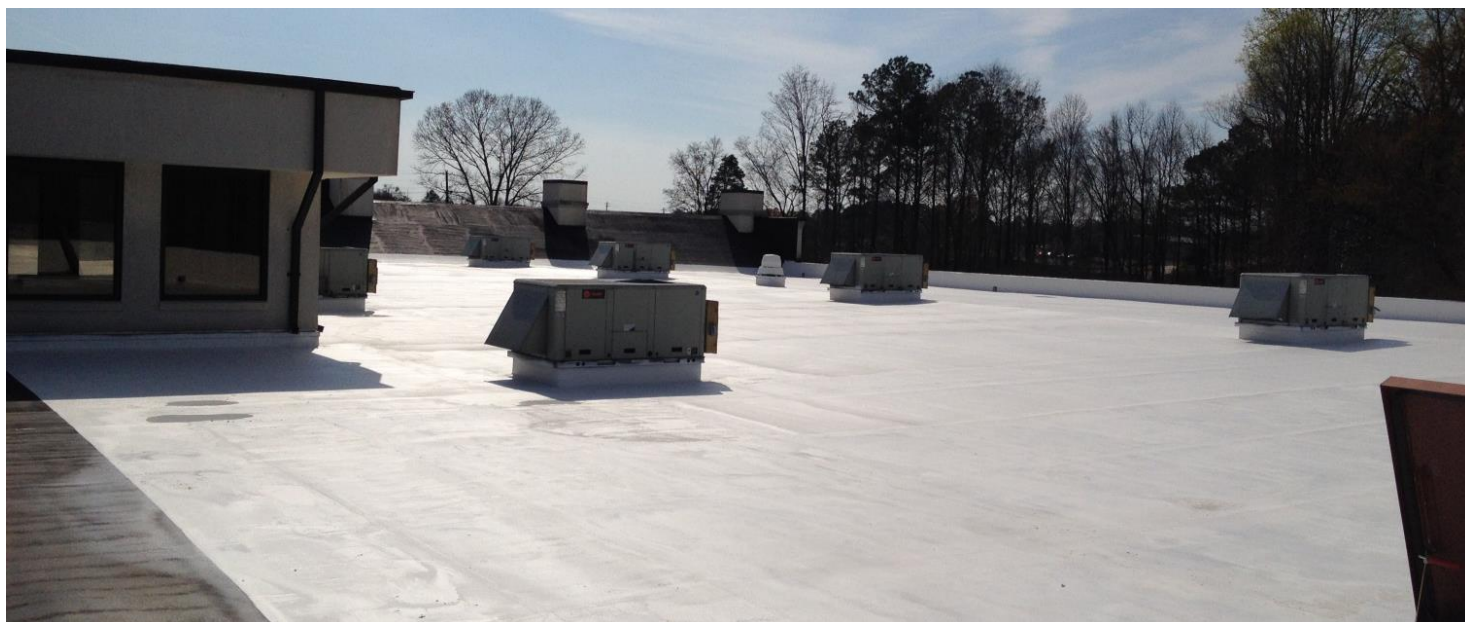
**This healthcare facility can rest assured they will have no disruptions to their operations due to a leaking roof and they now have a cooler, hail-resistant roof system.**
