Southern Atlantic Spring
Factory Metal Roof Restoration

Granite Quarry, NC

Triton Metal Prime
80 mil TritoFlex 2K and 1K on
seams, fasteners, and penetrations
20 mil TritoTherm ceramic topcoat

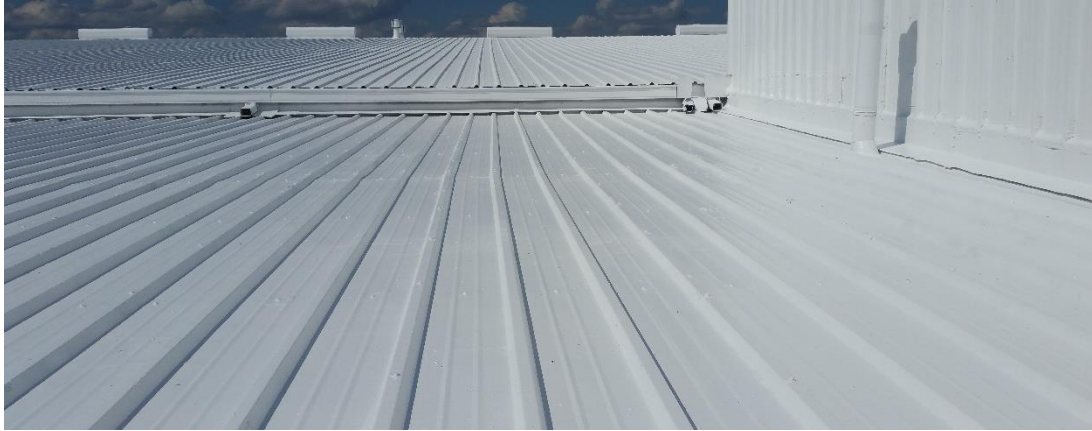
In addition to hundreds of leaks across multiple types of metal roof systems, heavy rust and corrosion was occurring in this humid Carolina climate. Due to the cost and disruption, a complete replacement of metal wasn't an option. A single-ply overlay would also be expensive and potentially lead to structural concerns with a change in water weight distribution. Liquid-applied restoration made the most sense. But out of all the roof coatings on the market, which one would work best?

The roof was first pressure washed and primed with Triton's Metal Prime, a rust-inhibiting coating. Loose and missing fasteners were replaced and then TritoFlex 2K was spray-applied to 80 mils dry on all seams, butt joints, penetrations, transitions, and flashings. TritoFlex 1K was quickly applied at 80 mils dry on all fasteners.

The contractor then applied two coats of TritoTherm acrylic ceramic coating over the entire roof surface to provide UV protection, extend the life of the existing metal, and drastically reduce heat transfer with its unique nanotechnology. The client was provided a 10-year material and labor leak-free warranty and the peace of mind they made the right choice choosing a Triton restoration system.
