# CASE STUDY

Hail-Damaged Roof Recover  
Nationwide Insurance Offices

60 mil TRITOflex membrane  
20 mil TRITOtherm ceramic coat

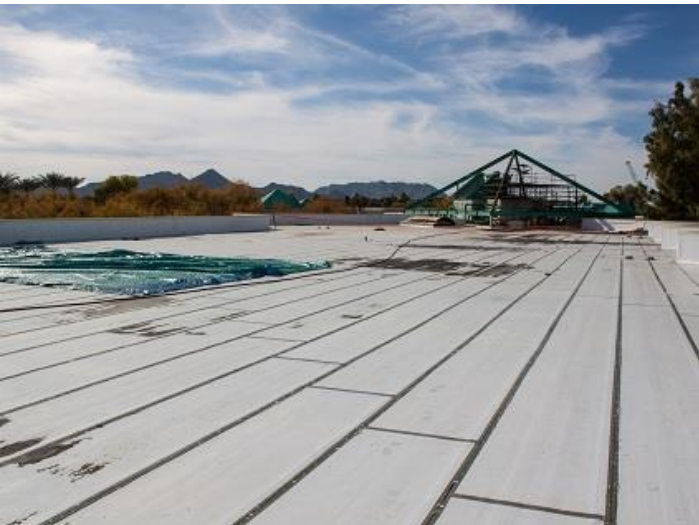
The client only had their new laminate-surfaced two-ply modified bitumen roofing system installed for two-years before a major hail storm severely damaged it, resulting in ripped seams, punctures and a fractures laminate surface. Although the hail strikes damaged the modified bitumen roof membrane, the underlying insulation was undamaged and could be salvaged.

The client was presented with the two best options by the consultant. The first option was to do what they had done two years prior and tear-off the entire modified system down to the concrete decking and start all over. The second option was to have the roof recovered with the TRITOflex fluid-applied, instant-setting rubber membrane, which is hail-resistant, has no seams, and has the highest FM wind uplift rating in the industry. Rather than going through the cost, labor, and disruption of tearing off the entire roof system again, the client chose TRITOflex to be installed over the existing hail damaged membrane. The client achieved a new 15-year warranty and saved \$500,000 over replacement cost.
