Nationwide Insurance Offices
Roof Restoration

Scottsdale, Arizona

60 mil TritoFlex 2K membrane
20 mil TritoTherm ceramic coat

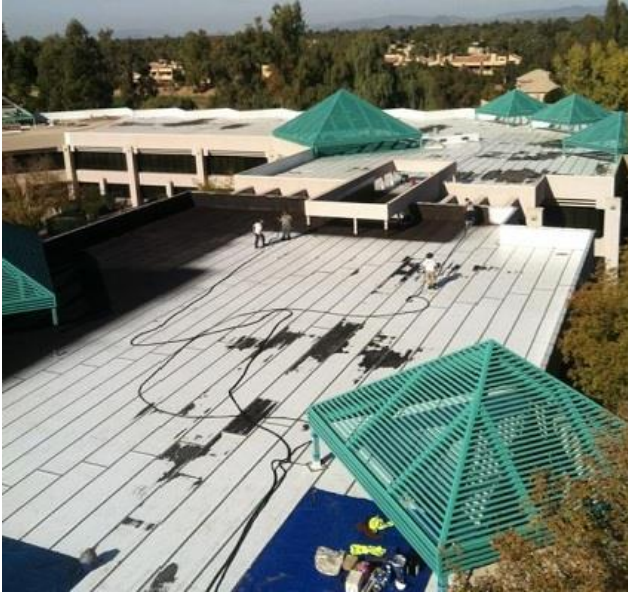
The client only had their new laminate-surfaced two-ply modified bitumen roofing system installed for two-years before a major hail storm severely damaged it, resulting in ripped seams, punctures and a fractured laminate surface. Although the hail strikes damaged the modified bitumen roof membrane, the underlying insulation was undamaged and could be salvaged before taking on moisture.

The TritoFlex 2K two-component rubberized membrane was installed in one coat with a spray application directly over the existing modified bitumen roof system to achieve a 60 mil/1.5mm seamless membrane. It was then top coated with a thermal insulating surface coat to provide superior energy cost savings in the hot Arizona climate. With an industry-leading FM-approved impact and hail resistance classification, the flexible TritoFlex membrane will protect this building from anything Mother Nature may bring at it in the future.
