CASE STUDY

HISTORIC WATER FOUNTAIN RESTORED

Manufacturer:	Triton, Inc.
Contractor:	Bligh Pacific
Building:	Office Plaza
General Contractor:	Swinerton Builders
Location:	Pasadena, CA

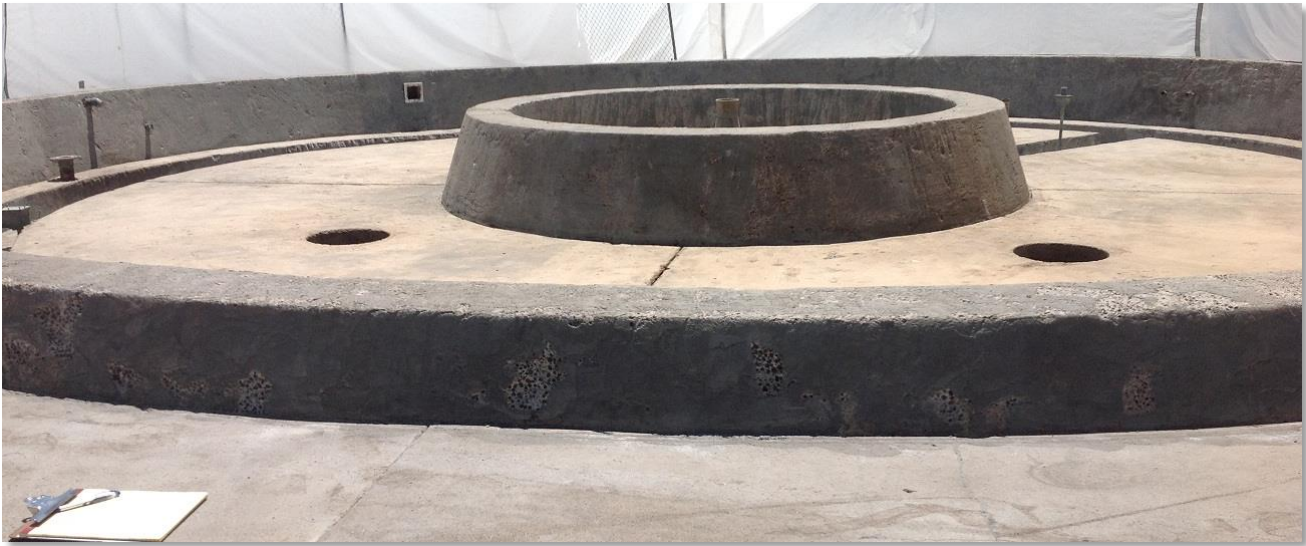
This historic water fountain in Pasadena was leaking into the underground parking garage below.

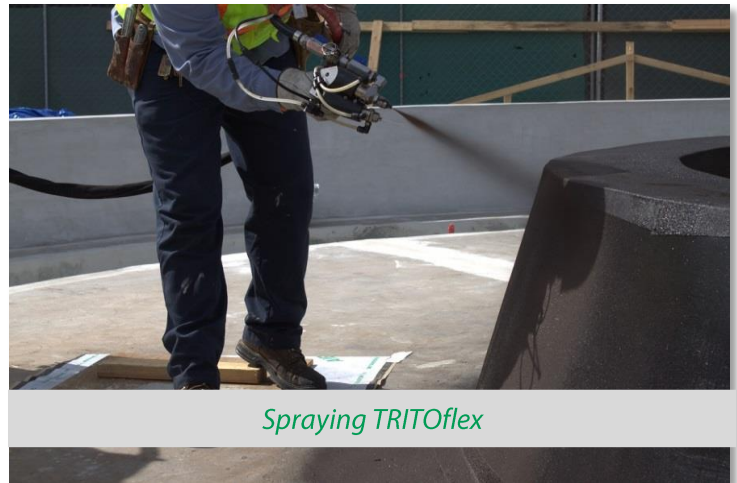
Spraying TRITOflex

The contractor was instructed to remove all of the fountain materials down to the original concrete and start over with new. The concrete was allowed to dry and then repaired. Next was determining which waterproofing membrane to use considering the difficult application and need to install tile directly on top. When all options were discussed by the team and many waterproofing manufacturers declined to guarantee their system for this application, the TRITOflex membrane was chosen. With 1,900% elongation, the ability to install at 80 mils dry in one coat, and high compatibility with thin-set mortar and tile, TRITOflex rose to the top.

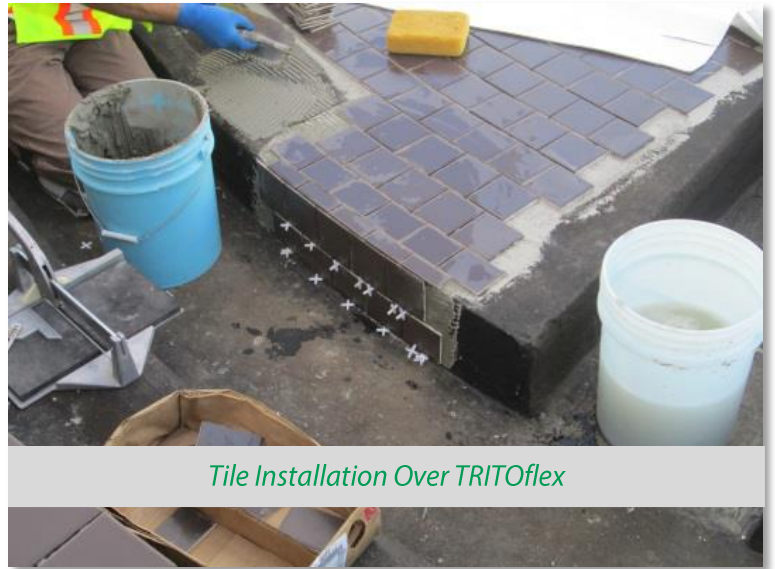
Tile Installation Over TRITOflex

TRITOflex was spray applied at 80 mils (2 mm) dry in one coat and the tile was adhered directly on top with thin-set mortar. The warranted TRITOflex membrane is able to withstand water indefinitely, making it an ideal choice for projects like water features, fountains, ponds, and planters.

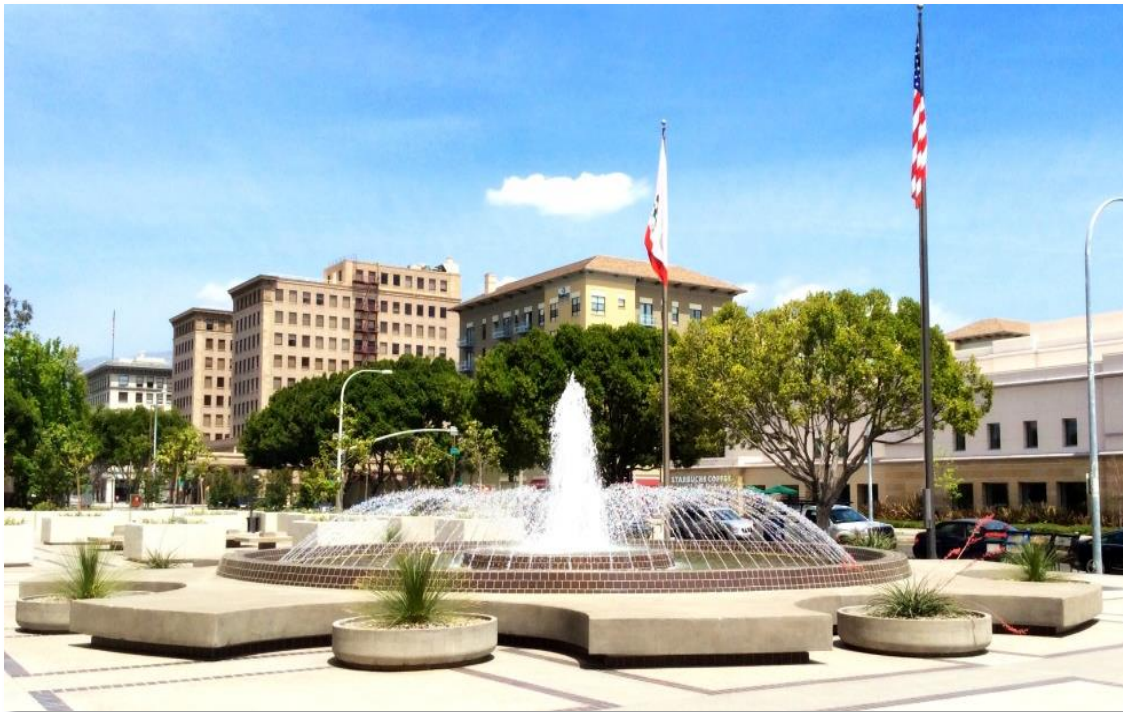
The client achieved a durable, flexible, and green rubber waterproofing membrane that will hold the decorative tile and keep this beautiful, historic water fountain from leaking below.
